NASA Technical Paper 1081

DECEMBER 1977

**Mechanical Behavior
and Fracture Characteristics
of Off-Axis Fiber Composites
I - Experimental Investigation**

John H. Sinclair and Christos C. Chamis
Lewis Research Center
Cleveland, Ohio

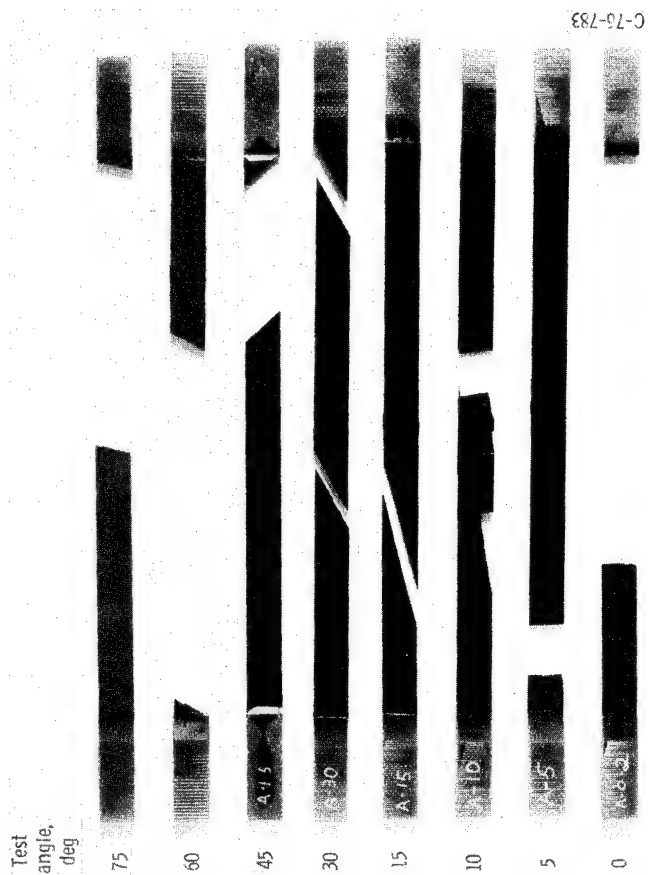
Figure 14. - Fractured test specimens (Mod I/E).

The fractured specimens are shown in figure 14. The fracture of a five-gage instrumented specimen is shown in figure 15. Note in figure 14 that the specimens tested at 0° , 5° , 10° , 15° , and 30° off-axis fractured away from the end tabs and those tested at 45° , 60° , 75° and 90° fractured near the end tab. Fractures occurring at or near end tabs are to be expected. Finite-element analyses results to be discussed in Part II show that the stresses at the edge near the end tab are higher than at the center in certain orientations. Consequently, these stresses can initiate fractures near the end-tab region. This leads to the interpretations that the fracture stresses of specimens that fractured near the end tabs are on the conservative side. Therefore, the axial stress

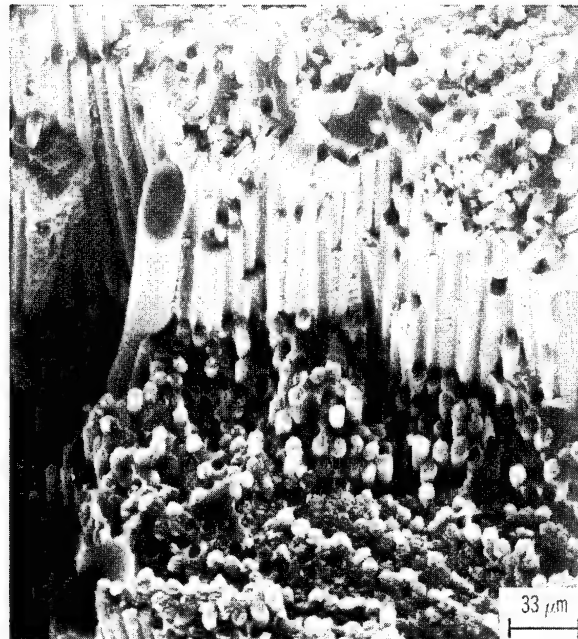
(a) General view.

(b) Detailed view.

(c) Enlargement of detail to show fracture mode.

Figure 17. - Scanning electron photomicrographs of fractured surface of Mod I/E composite tested at 5° to fiber direction.

The fracture surface of the 5° off-axis tensile specimen (fig. 17) reveals the following features:

- (1) Surface tiering (fig. 17(b)) and matrix cleavage (fig. 17(c)) both of which are indicative of tensile fracture
- (2) Extensive matrix surface lacerations, indicating substantial fracture by intralaminar shear
- (3) Fiber pull-out and fiber surfaces free of matrix residue, indicating weak interfacial bonding.

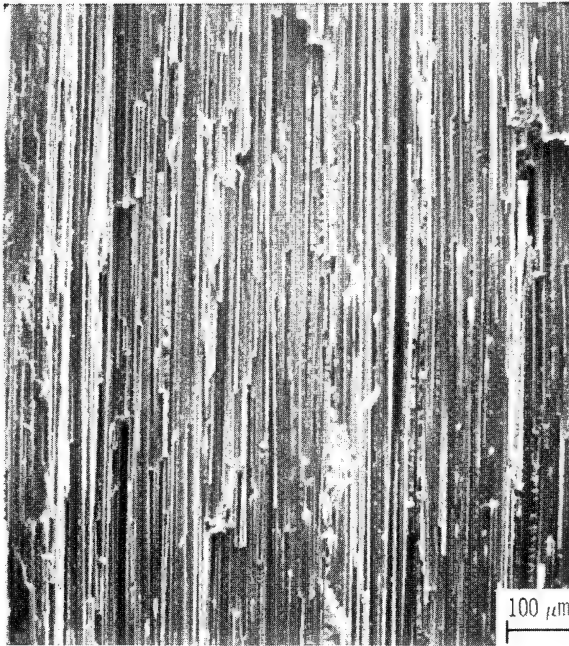
(a) General view.

(b) Detailed view.

(c) Enlargement of detail to show fracture mode.

Figure 18. - Scanning electron photomicrographs of fractured surface of Mod I/E composite tested at 10° to fiber direction.

The fracture of the 10° off-axis tensile specimen (fig. 18) reveals (1) matrix surface lacerations and (2) fiber surfaces free of matrix residue. Both of these features indicate that a different fracture mode became active. We will consider this mode to be induced by intralaminar shear stress. It is this observation and the theoretical considerations to be described in Part II that led to the recommendation that the 10° off-axis tensile specimen is suitable for intralaminar shear characterization of unidirectional fiber composites.

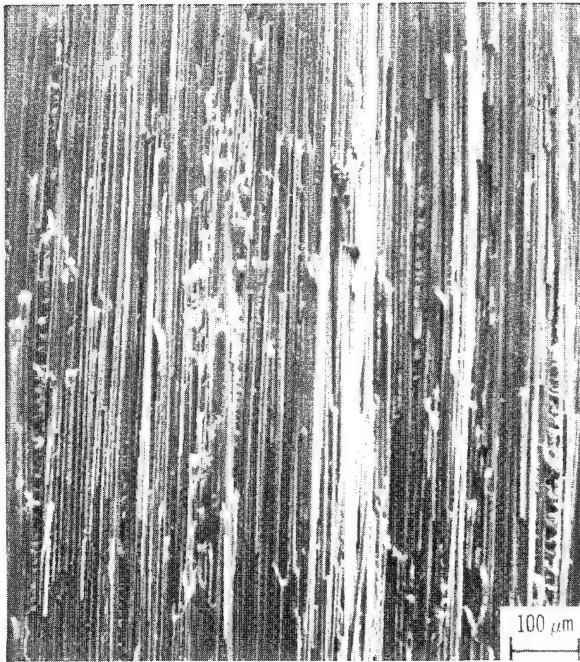
(a) General view.

(b) Detailed view.

(c) Enlargement of detail to show fracture mode.

Figure 19. - Scanning electron photomicrographs of fractured surface of Mod I/E composite tested at 15° to fiber direction.

The fracture surfaces of the 15° and 30° off-axis tensile specimens (figs. 19 and 20) reveal similar features to those of the 10° off-axis tensile specimen. These surfaces, too, indicate that fracture was induced mainly by intralaminar shear stress.

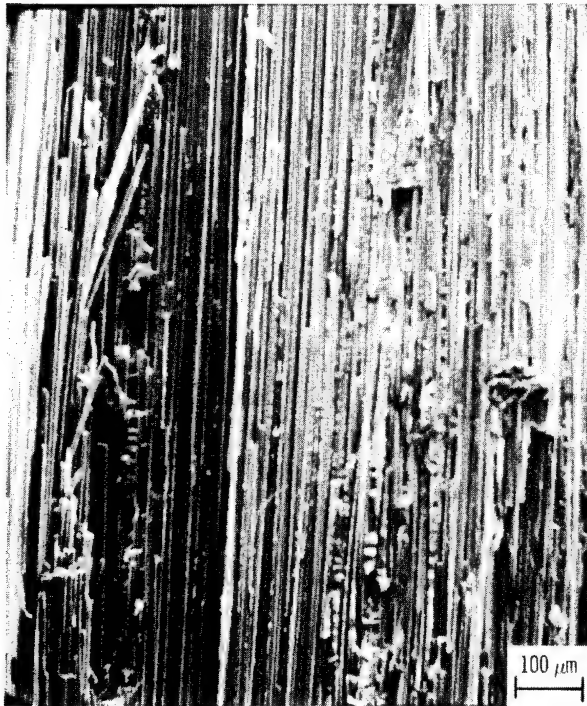
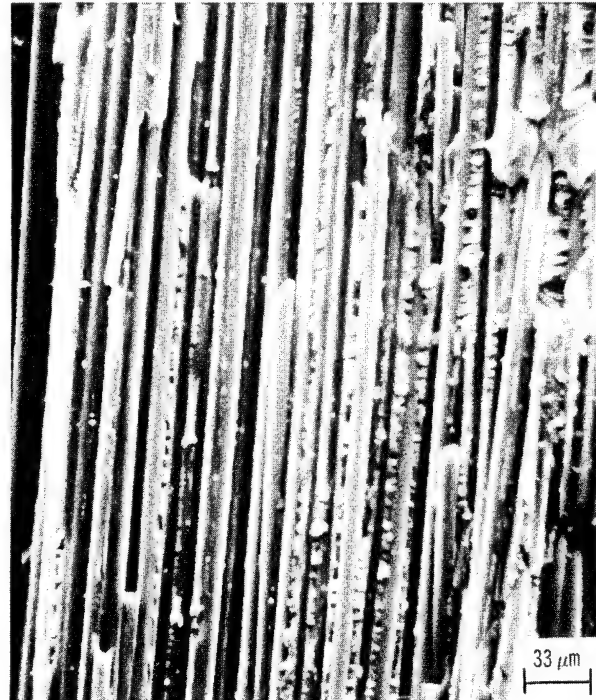
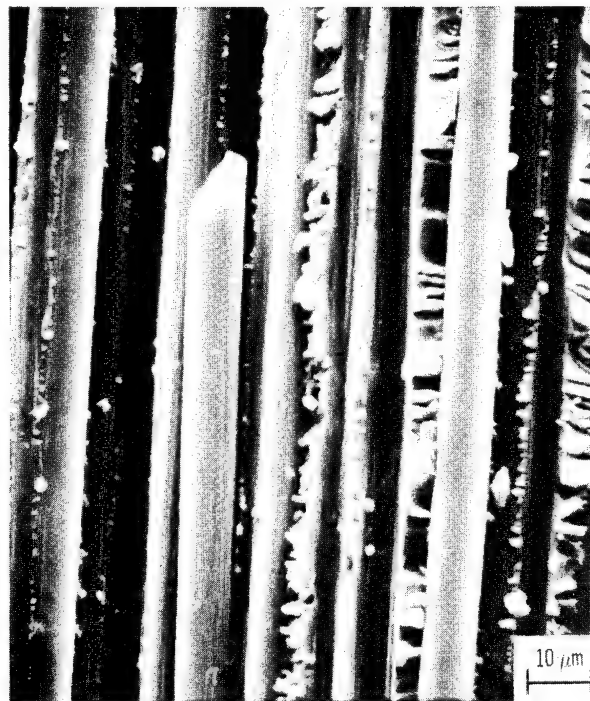
(a) General view.

(b) Detailed view.

(c) Enlargement of detail to show fracture mode.

Figure 20. - Scanning electron photomicrographs of fractured surface of Mod I/E composite tested at 30° to fiber direction.

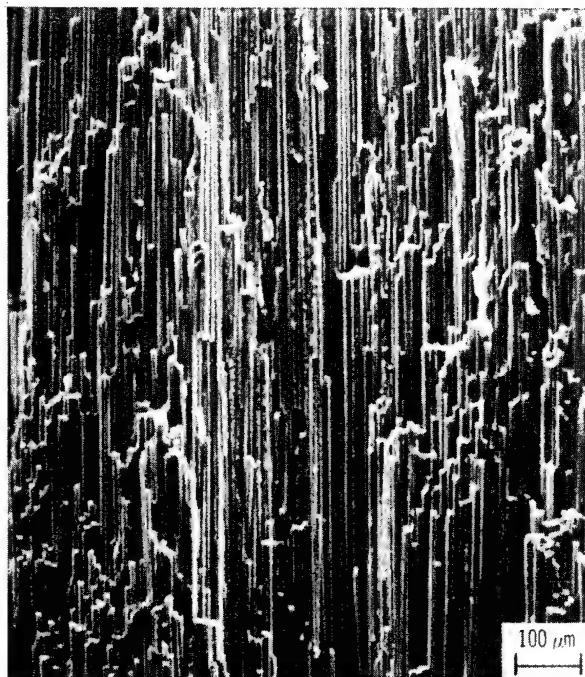
(a) General view.

(b) Detailed view.

(c) Enlargement of detail to show fracture mode.

Figure 21. - Scanning electron photomicrographs of fractured surface of Mod I/E composite tested at 45° to fiber direction.

The fracture surface of the 45° off-axis specimen (fig. 21) reveals the following features:

- (1) Matrix cleavage with irregular boundary, indicating some transverse tensile fracture
- (2) Matrix debris resulting probably from tensile matrix fracture
- (3) Some matrix lacerations, indicating some intralaminar shear stress fracture.

These surface fracture features show that another fracture mode becomes active somewhere between a load angle of 30° and 45° . This mode is construed to have been induced by the transverse tensile stress.

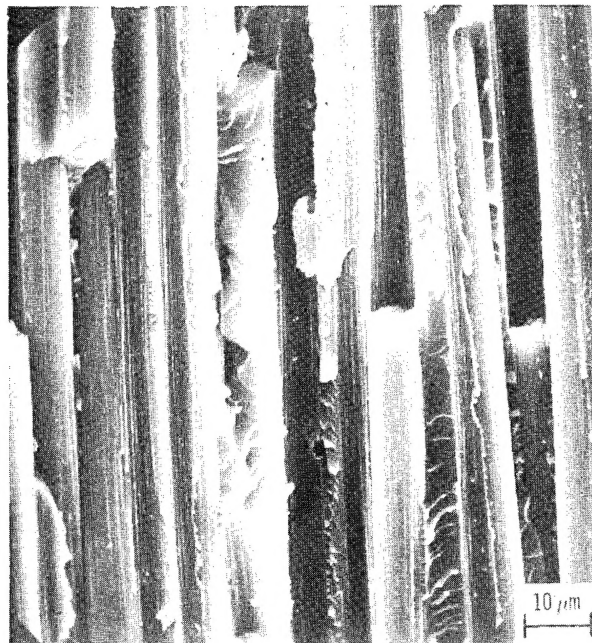
(a) General view.

(b) Detailed view.

(c) Enlargement of detail to show fracture mode.

Figure 22. - Scanning electron photomicrographs of fractured surface of Mod I/E composite tested at 60° to fiber direction.

The fracture surfaces of the 60° off-axis tensile specimen (fig. 22) and the 75° specimen (fig. 23) reveal mainly matrix cleavage and some fiber surface free of matrix residue; both of these features indicate that fracture was induced by transverse tensile stress.

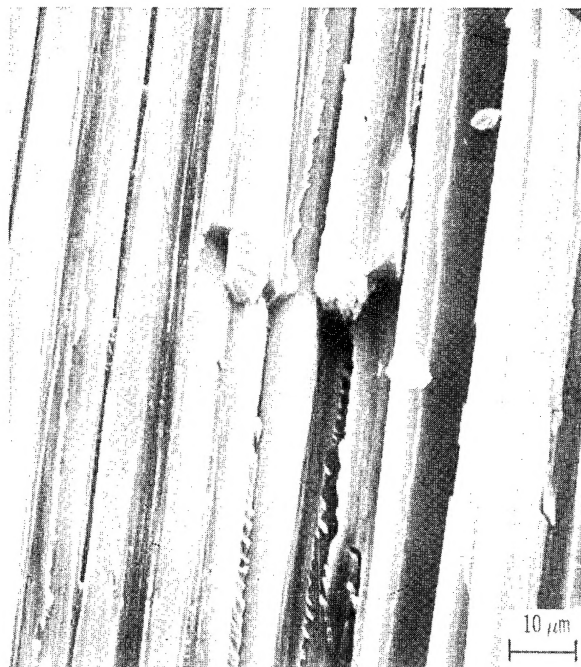
(a) General view.

(b) Detailed view.

(c) Enlargement of detail to show fracture mode.

Figure 23. - Scanning electron photomicrographs of fractured surface of Mod I/E composite tested at 75° to fiber direction.

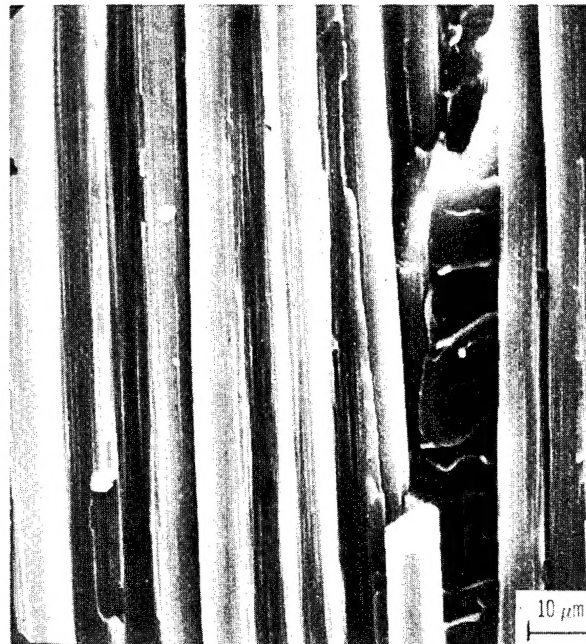
(a) General view.

(b) Detailed view.

(c) Enlargement of detail to show fracture mode.

Figure 24. - Scanning electron photomicrographs of fractured surface of Mod I/E composite tested transverse to fiber direction.

The fracture surface of the 90° tensile specimen (fig. 24) reveals the following features:

- (1) Matrix cleavage, indicative of tensile fracture of brittle materials
- (2) Fiber surfaces free of matrix residue, indicative of weak interfacial bond, as was already mentioned
- (3) Some matrix lacerations, indicating shear fracture at surfaces connecting two different levels.

These features indicate that transverse tensile stress produces fracture surfaces characterized by (1) matrix cleavage and (2) fiber surfaces clear of matrix residue.
